## Effect of Latex Modified Concrete Overlays With Reduced Surface Preparation on the Load Distribution and Flexural Strength of Channel Girders

EFFECT OF LATEX MODIFIED CONCRETE OVERLAYS WITH REDUCED  
SURFACE PREPARATION ON THE LOAD DISTRIBUTION AND FLEXURAL  
STRENGTH OF CHANNEL GIRDERS

A Thesis  
Presented to  
the Graduate School of  
Clemson University

In Partial Fulfillment  
of the Requirements for the Degree  
Master of Science  
Civil Engineering

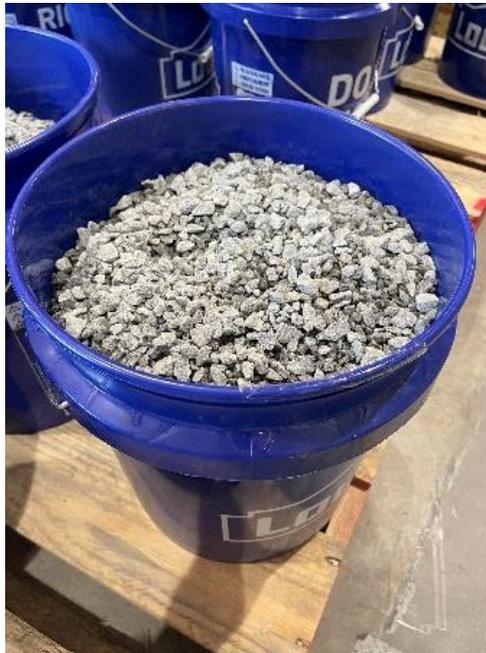
Figure 3.1: #789 Washed Stone Sample

All three mixes used the same coarse aggregate (#789 Washed Stone, Figure 3.1), fine aggregate (manufactured sand, Figure 3.2), Latex Admixture (Figure 3.3) and tap water. Each mix varied slightly in their amounts of each material. The principal difference between the mix designs was the type of cement. Mix one used standard, type

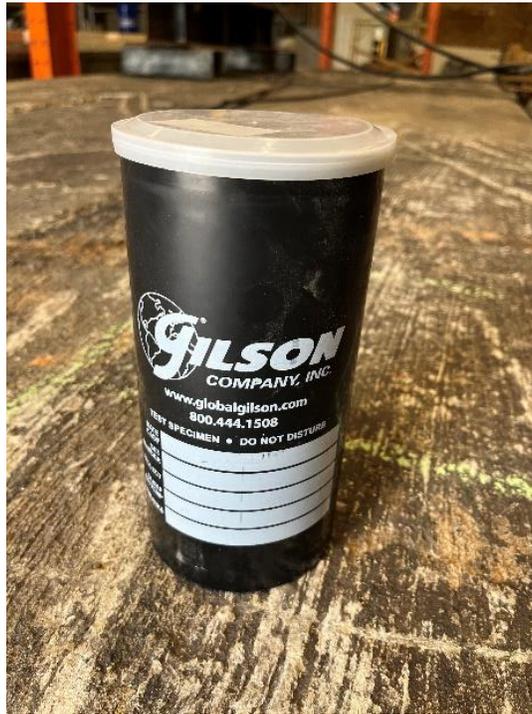
Figure 3.4: Standard 4” x 8” Cylinder

2021). Each of the three mixes were planned to be tested at one-, three-, and seven-day strength with four cylinders being tested at each time stamp for a total of thirty-six compression tests. These cylinders were to be standard 4” by 8” cylinders (Figure 3.4).

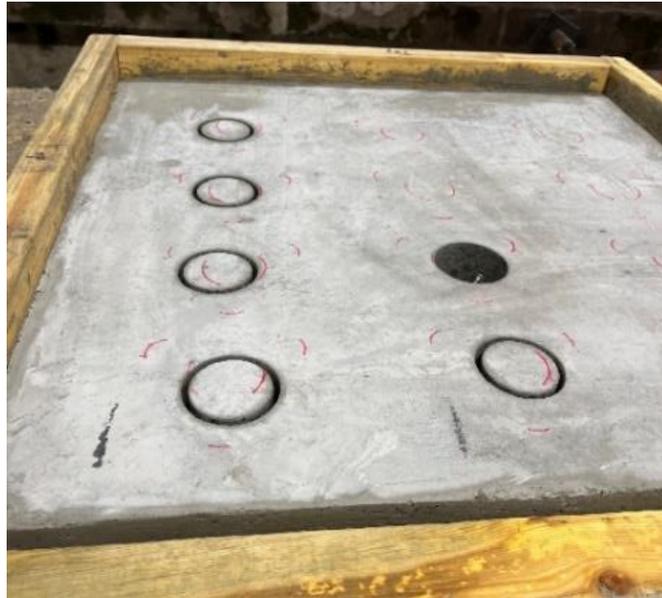
Figure 3.5: Test Area with Cores

The bond strength of the mixes was tested via a standard pull-off test based on ASTM C1583 (ASTM, 2020) The pull-off tests were performed on two-inch diameter specimens cored from a two-foot, three-inch square test area (Figure 3.5). The two-inch diameter specimens were cored through the LMC overlay and then one inch into the existing girder.

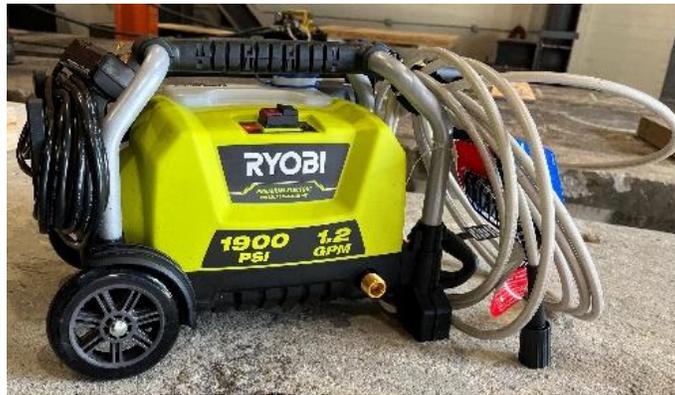
Figure 3.6: Pressure Washer used in Material Testing

The pull off testing was performed for two types of surface preparation. In both methods, the surfaces were initially cleaned with a broom. In method one, the surface of the test area was pressure washed with a small, electric pressure washer (Figure 3.6). In method two, the surface of the girder was scarified longitudinally and perpendicularly with a steel wire brush (Figure 3.7). Figure 3.8 presents the concrete appearance after the different surface preparation methods. Between the different mix designs and surface preparation methods, a total of six test areas were planned to be made. The bond strength of each test area was planned to be tested at three and seven-day strengths. Six pull-off tests were planned for each test area at each timestamp, resulting in a planned total of seventy-two pull-off tests. A summary of the planned material testing can be found below in Table 3.2.

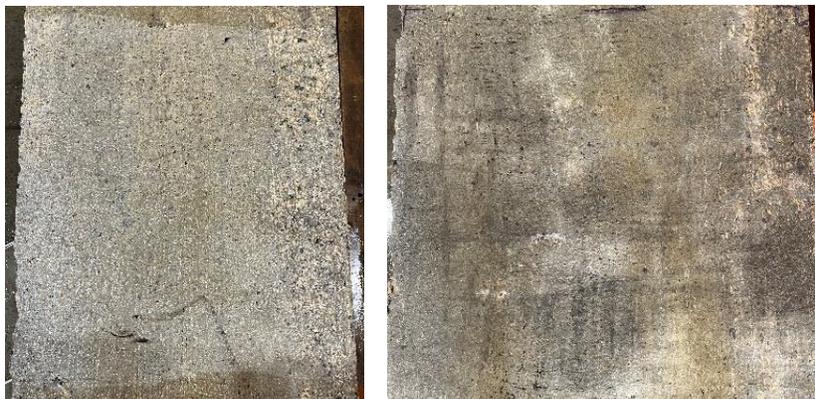
Figure 3.8: Typical Pressure Washed (Left) and Steel Brushed (Right) Test Areas

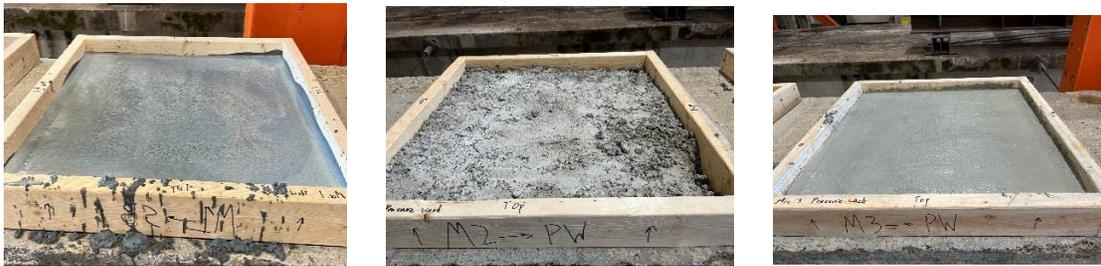
The specimens for materials testing were cast on May 22, 2023. Mix one was mixed first and several issues were encountered. The aggregate received from Vulcan was fairly saturated with water which was not accounted for when portioning the materials for mix one. Therefore, the water content of mix one was too high, and the mix was extremely fluid. Despite the high moisture content, the test areas and cylinders were cast without any major issues (Figure 3.9 , Left). Mix two was cast second and an attempt was made to adjust the mix design for the high moisture content of the aggregate. However, this attempt overcorrected, and the mix was far too stiff. While there was an attempt to cast the cylinders and test areas only the cylinders were usable – the mix set too rapidly to successfully pour and finish the test areas (Figure 3.9, Center). Given the issues with mixes one and two, it was decided to not proceed with mix three and

reattempt mix two. This time, the moisture content was decreased to around two-thirds of the originally planned water content to adjust for the aggregate. Revised mix two had acceptable moisture content and allowed for a smooth casting of the test areas and some cylinders (Figure 3.9, Right). Emphasis was placed on the placement of LMC for the bond test areas, therefore the mix set before all the planned cylinders could be cast. For all tests the bond test areas were cleaned and dried after their surface preparation.

Figure 3.9: Mix One (Left), Mix Two (Center), and Mix 3 (Right) Material Testing Areas

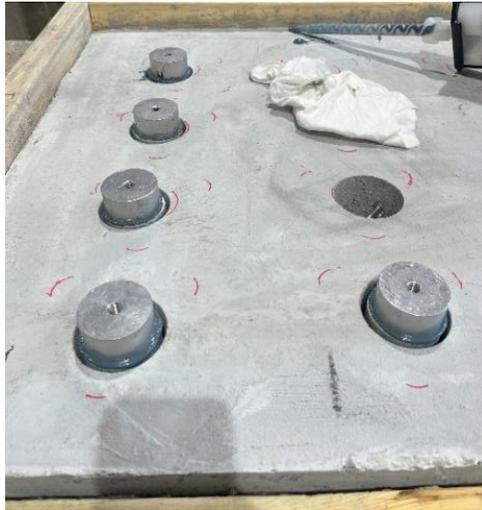
Figure 3.10: Successful Pull-Off Specimens

In order to perform pull-off testing, the specimens had to be prepared no less than two days before the desired timestamp in order to give the epoxy time to harden. This meant that the specimens for three-day bond strength needed to be prepared after only setting for one day. However, mix one had gained so little strength at one day that the mix itself broke under the force of the core drill. This poor performance of mix one led to

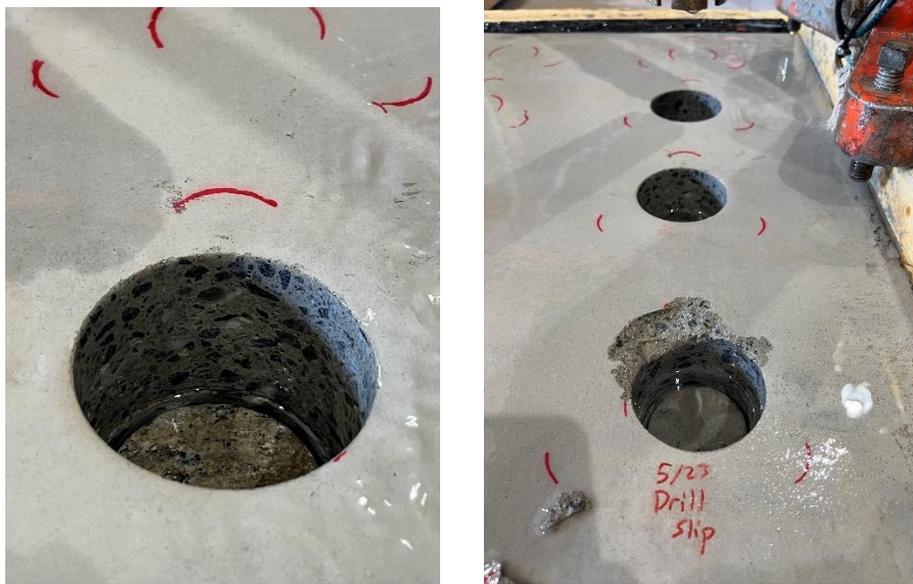
its elimination as a suitable material to investigate for flexural testing. The rationale for this decision came from two factors. One, the poor performance of mix one made it impossible to make a judgement on its performance at a large scale. Secondly, many cases of bridge repair require a quick timeline and a mix that cannot gain enough strength after twenty-four hours to resist the force of a core drill will be unsuitable to use on a bridge. Both test areas for mix two (successful) were successfully poured, but only one test area yielded specimens for bond testing. Five specimens were successfully prepared from the test area for pressure washing and mix two (successful) (Figure 3.10). On the first attempt to prepare a specimen for the steel brushed, mix two (successful) test area the core drill slipped off its bearings, damaging both the in-progress specimen and coring bit. Unfortunately, the lab contained no spare bits, so in order to ease comparisons in data all pull-off testing was postponed to seven-day strength. Upon the purchase of new coring bits, attempts to prepare specimens for the steel brushed, mix two (successful) test area failed. The steel brush method of surface preparation created a bond which could not resist the rotary force of the core drill (Figure 3.11 ). Accordingly, the steel brush method of surface preparation was also removed from consideration for continued testing.

Figure 3.11: Broken Cores from the Steel Brush Test Area

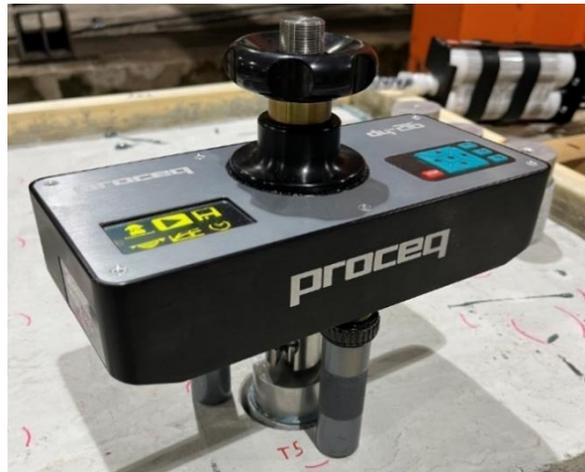
Figure 3.12: Proceq Digital Pull-Off Tester

The five pull-off specimens were tested at seven-day strength on May 29, 2023. The specimens were tested with a Proceq digital pull-off tester to failure (Figure 3.12). Each specimen failed at the bond interface (Figure 3.13) with bond strengths ranging from 171 psi to 270 psi (Table 3.3). The average bond strength of the samples was 213 psi with a standard deviation of 37.2 psi. All pull-off tests failed at the interface of the precast girder and the LMC.

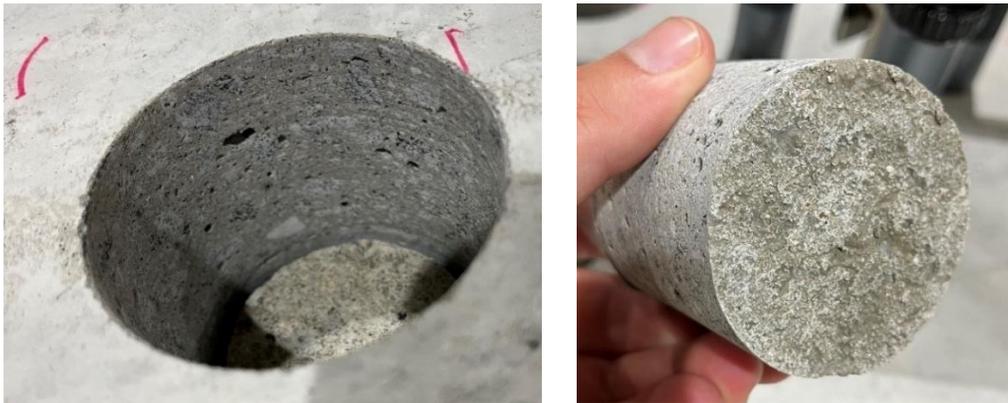
Figure 3.13: Typical Bond Failure of Pull-Off Specimens

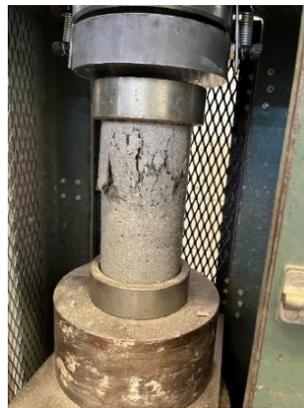
Three cylinders from mix one and two and two cylinders from mix two (successful) were tested for compressive strength at seven-days (Figure 3.14). The results from these tests are presented below in Table 3.4. The average compressive strength for mixes one, two, and two (successful) at seven-day strength were 2530 psi, 7180 psi, and 6650 psi, respectively. The twenty-eight-day strengths for mix one, two, and two (successful) were 4830 psi, 8030 psi, and 7550 psi respectively.

Figure 3.14: Typical Compression Test

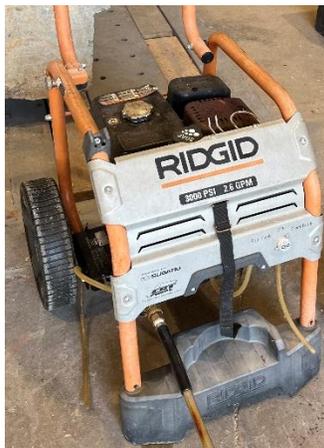
The construction of the LMC overlay had four main stages: surface preparation, form construction, strand tensioning, and placing of overlay. The first stage of the LMC overlay's construction involved preparing the surfaces of the girders to facilitate a bond with the overlay. Based on the results of the materials testing, the surface was prepared with a 3000 psi pressure washer (Figure 4.2).

Figure 4.2: Pressure Washer Used in Surface Preparation

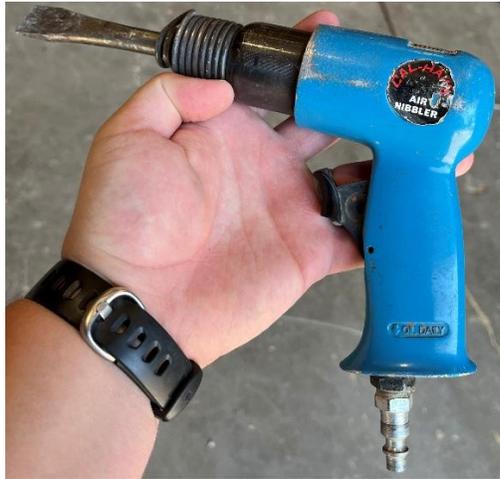
Figure 4.3: Pneumatic Chisel

Each girder's surface was prepared individually following the same process: most residual asphalt was removed by a hand-held, pneumatic chisel (Figure 4.3) and then the girder surface was washed by the pressure washer. Not all of the asphalt was removed in an effort to simulate a lower-bound, quick and efficient repair job that could be easily repeated in the field. After the wash, the entire surface was pressure washed with the nozzle held approximately ¼" away from the surface (Figure 4.4), and finally the girder's surface was rinsed one last time.

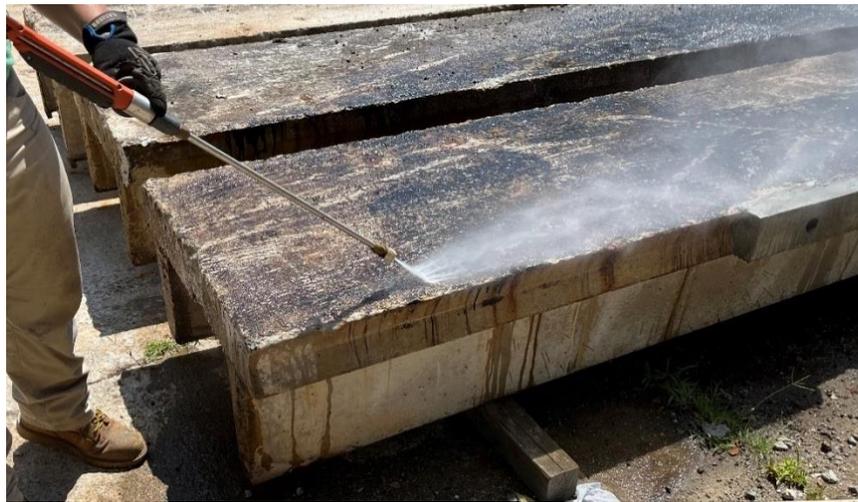
Figure 4.4: Pressure Washing Girder Surface

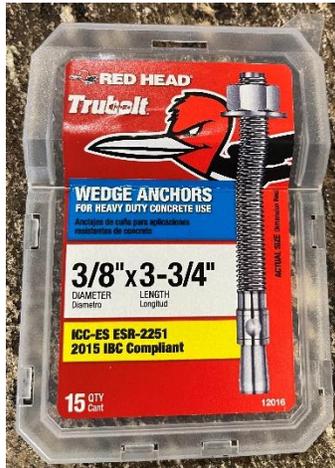
After the girder's surfaces were prepared, the girders were moved back inside the lab and the overlay's forms were constructed. These forms were made out of redhead concrete anchors and nominal 2" x 4" inch lumber (Figure 4.5).

Figure 4.5: Concrete Anchors used in Form Construction

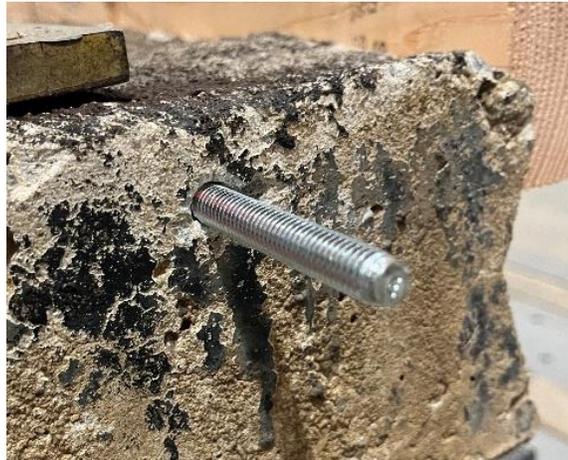
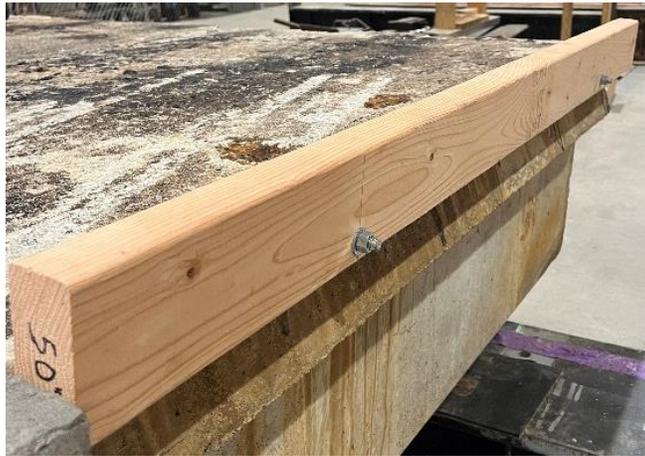
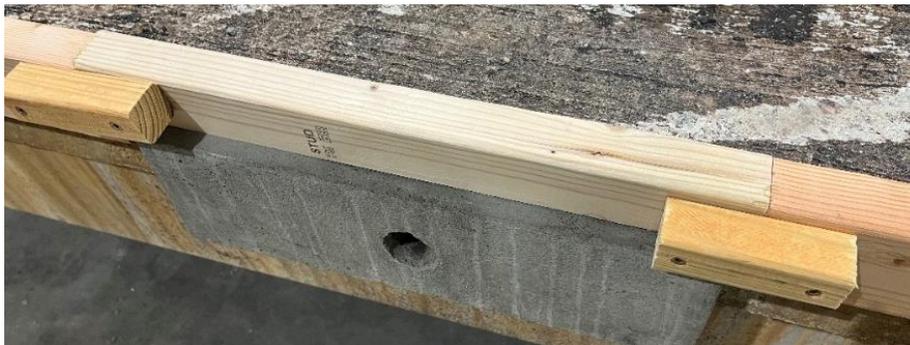
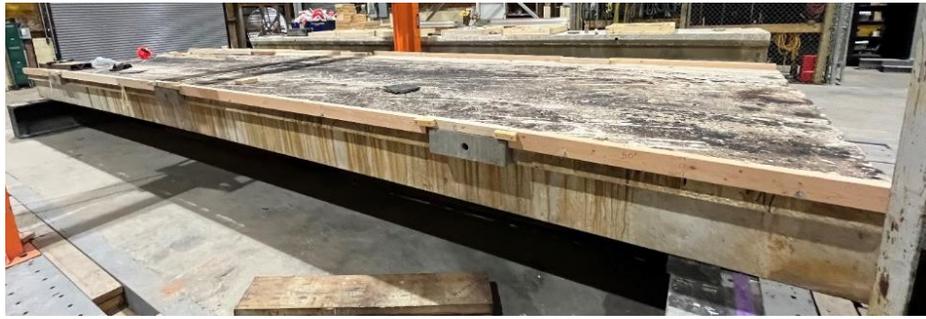
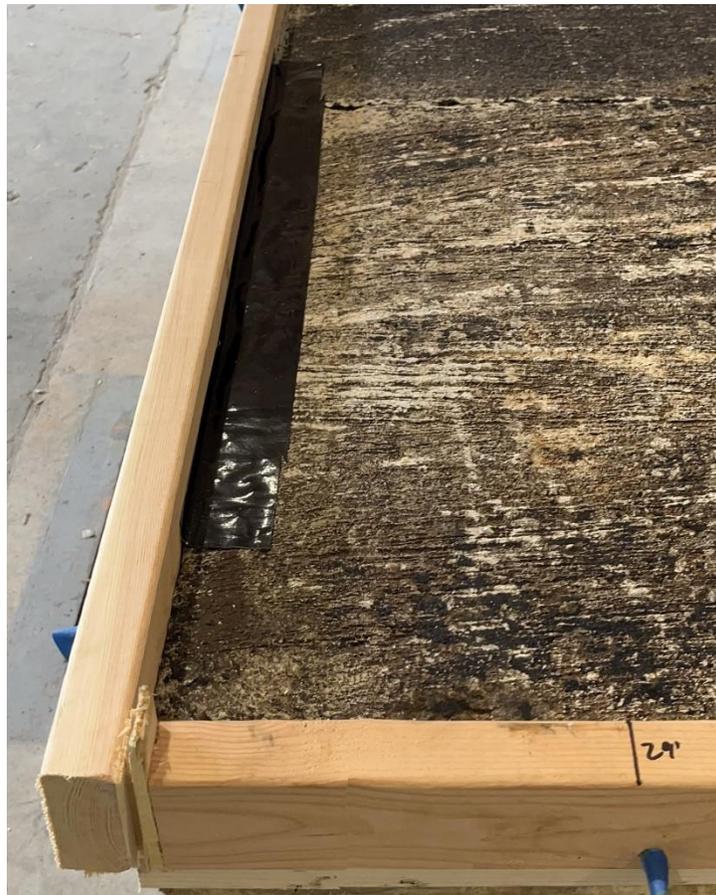
Due to the mortar blocks cast around the east girder's shear keys the forms had to be divided into multiple pieces. A typical piece of the forms was installed via the following method: the redhead anchor was installed approximately  $\frac{3}{4}$ " below the top of the girder. Holes were then drilled in the nominally 2" x 4" lumber at the proper location to ensure two inches of the lumber extended above the girder surface. The lumber was then slid onto the anchor where a washer and nut secured the lumber to the girder. Small scab pieces of lumber were used to span the mortar blocks on the east girder and the corresponding areas on the west girder where the post-tensioning strand required bearing area. Smaller gaps (spalled concrete, imperfections in the wood, etc...) were patched with construction adhesive or tape. See Figure 4.6, Figure 4.7, Figure 4.8, Figure 4.9, and Figure 4.10 below for several pictures from the form construction process.

Figure 4.6: Installed Concrete Anchor

Figure 4.7: Typical Form Piece

Figure 4.8: Typical Slab over Mortar Block

Figure 4.9: Overall Picture of Nearly Complete Forms

Figure 4.10: Example of Tape used to Patch Section

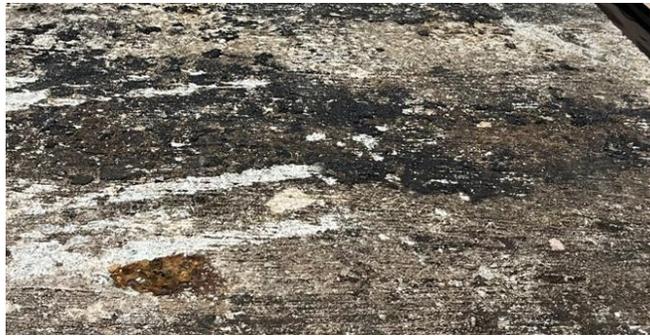
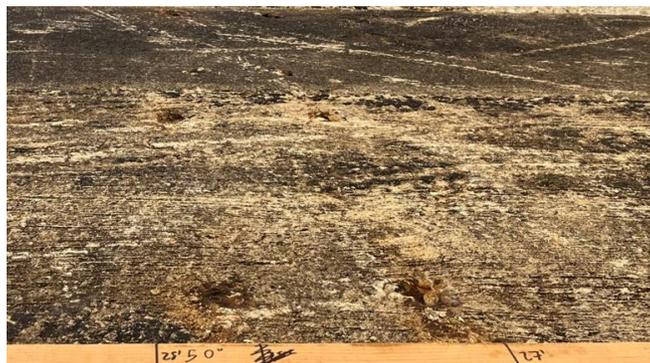
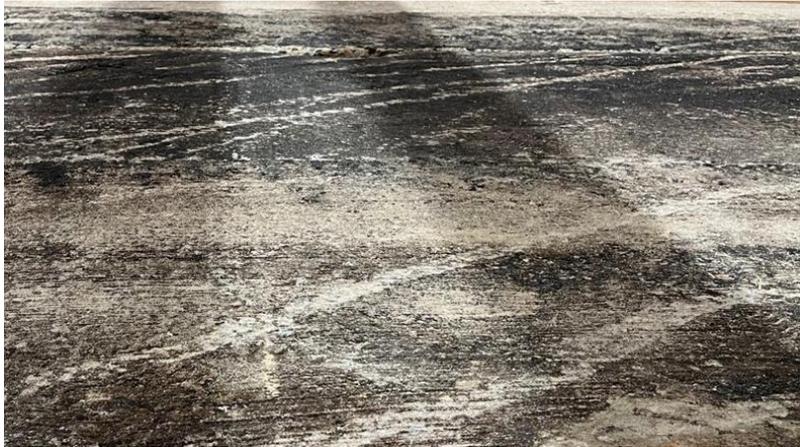
provided by this contractor. Their familiarity with the mix and its placing was another reason for the decision to seek their assistance. Modified Concrete LLC provided labor and a truck containing the necessary water, cement, latex admixture, and mixer. The natural sand and #789 washed stone were purchased from Vulcan Materials company. The overlay was mixed on the truck and then poured on the girder system by a telehandler forklift rented from Blanchard Machinery (Figure 4.14). The girder surface had been dried and cleaned prior to the pouring of the overlay. See Figure 4.11, Figure 4.12, and Figure 4.13 below for pictures of the girder surface before the placement of the overlay.

Figure 4.11: Typical Surface of Girder Prior to Overlay

as compared to the test batches. While the true reason for this is unknown, the most probable reason is the use of natural sand for the overlay as opposed to the manufactured sand in the test batches. Manufactured sand is more angular than natural sand and can create a better bond with the concrete itself, increasing the strength of the mix. The second item is the strength gain over time of the LMC overlay. As seen in Figure 4.17, the LMC overlay showcased a rapid gain in strength over three days which then quickly slowed down. This rapid initial strength gain is a result of the use of rapid set cement and evidenced in that the concrete reached nearly 80% of its twenty-eight-day strength at only three days. This is a beneficial property for bridge repair as it means the bridge could be opened much faster than with traditional concrete. The final item worth discussing is the relatively low bond strength values compared to the material testing. While the exact cause of this difference is also unknown, the most likely reason is poor bonding conditions on the channel girder system due to remaining asphalt, dirt/dust, or other similar factors (Figure 4.11, Figure 4.12, and Figure 4.13). See Figure 4.19 below for a typical surface of an overlay pull-off specimen.

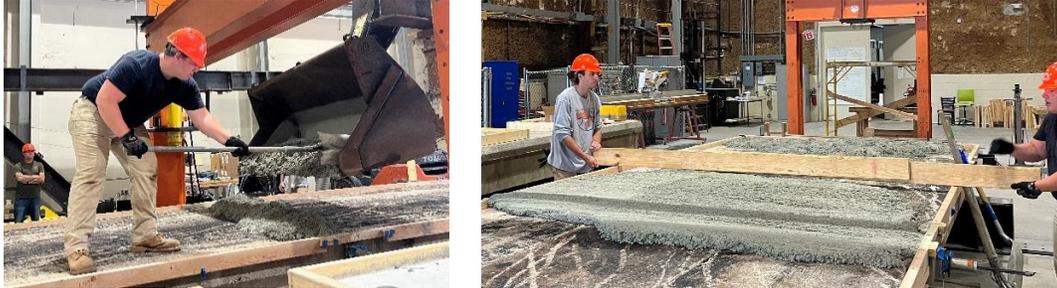
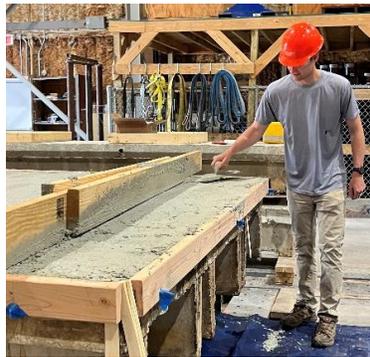
The poured LMC was then spread via shovels, a home-made screed, and trowels (Figure 4.15 and Figure 4.16). This process was repeated multiple times due to the limited capacity of the telehandler bucket. Finally, the overlay was misted several times throughout the rest of the day to support curing. It should also be noted that a vibrator was not used in either the material testing or overlay placement. However, later

Figure 4.15: Spreading LMC with Shovels and Screed

Figure 4.16: Finishing LMC Overlay with Trowel

destructive testing revealed good consolidation despite the inability to vibrate the mix during casting.

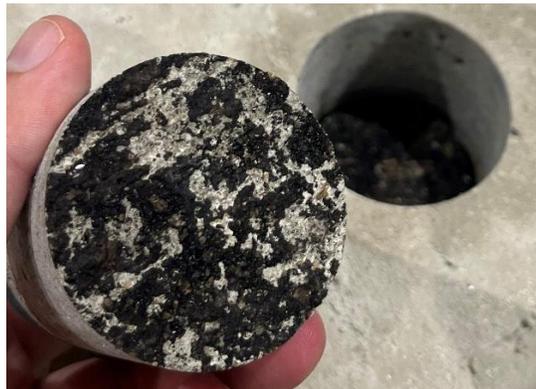
Figure 4.19: Typical Bond Surface of Overlay Specimens

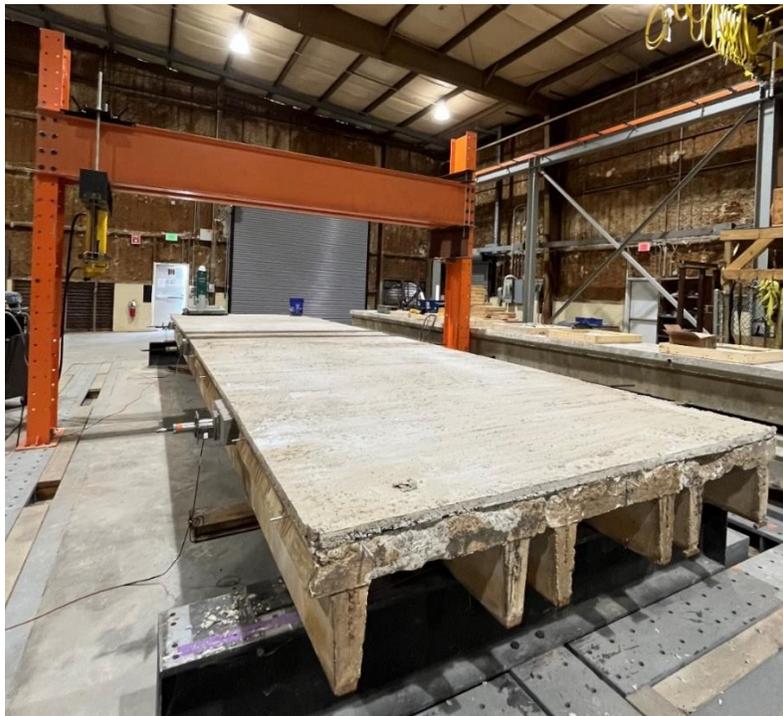
Figure 4.20: Overall Testing Setup

Before discussing the testing and performance of the system, a discussion of the system's testing setup is required. A picture of the overall test setup can be found below in Figure 4.20 . The setup for the system testing can be divided into two sections: instrumentation and load application. The system was instrumented with six wire potentiometers (Figure 4.21), three load cells (Figure 4.22), and one pressure gauge (Figure 4.23). The six wire potentiometers were positioned at the midspan of the girders to measure midspan vertical deflections. Each girder received two wire potentiometers, with one glued to the inside of each girder's web. These wire potentiometers were labeled relative to two factors: the designation of the wire potentiometer's girder (west, center, or east) and whether the wire potentiometer was on the western or eastern web. For example, the wire potentiometer located on the western web of the center girder would be labeled as the CW wire potentiometer. The three load cells were used to measure the force in each post-tensioning strand over time. The load cells were labeled based on the designation given to the corresponding strand. However, only the center load cell data recorded continuously with the wire potentiometers. The north and south load cells were

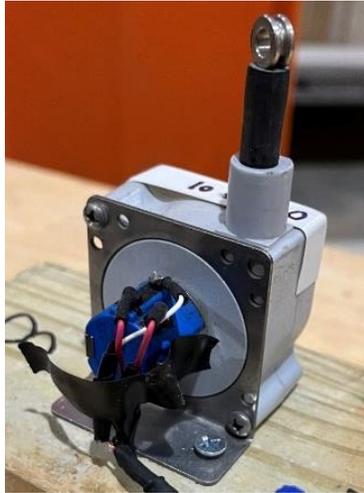
Figure 4.21: Typical Wire Potentiometer

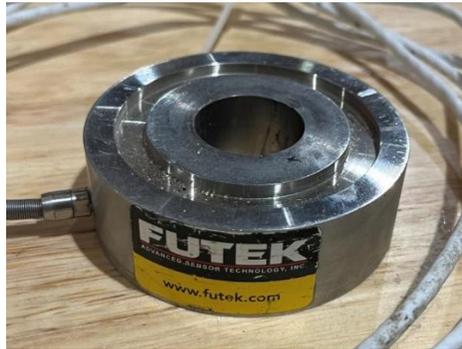
Figure 4.22: Typical Load Cell

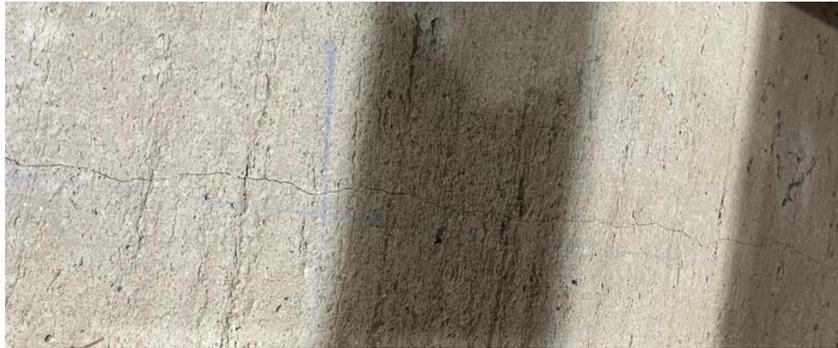
Figure 4.33: Reflective Cracking of LMC Overlay prior to removal of post-tensioning

The first stopping criteria reached during the test was the thirty-seven-kip load limit. However, the system had shown little change in behavior and the researchers determined it was safe to continue the test. At that point, the load limit was increased to sixty kips with the other stopping criteria remaining the same and in the same order of importance. As the test continued, the girders and overlay were monitored for flexural and reflective cracking in addition to delamination. However, the delamination check was ceased after a load of forty-five kips was reached due to concerns regarding the safety of chain dragging such a highly loaded system. At around fifty kips of load several small flexural cracks were noticed in the outside edges of the eastern and western girders. Finally, the system achieved its peak load at around fifty-seven kips. At this peak load, the LMC overlay experienced a rapid, destructive reflective cracking that spanned the entire length of the overlay (Figure 4.33). This reflective crack roughly followed the longitudinal joint between the east and center girders and penetrated through the entire overlay. Also, later removal of the post-tensioning slightly opened the reflective crack (Figure 4.34).

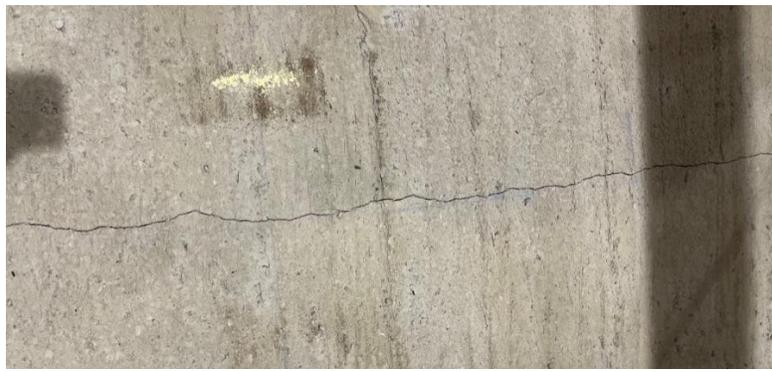
Figure 4.34: Reflective Cracking of LMC Overlay after removal of post-tensioning

At the conclusion of the test, chain dragging of the reflective crack revealed only six to eight inches of overlay on each side of the crack delaminated. The chain dragging followed the standard procedure of dragging a steel chain over the surface and listening for the hollow sounds which indicate delamination. At the same time the reflective crack appeared, the force in each post-tensioning strand increased by around 1.5 kips. Figure 4.35 below presents the load-displacement curve for the high load test.

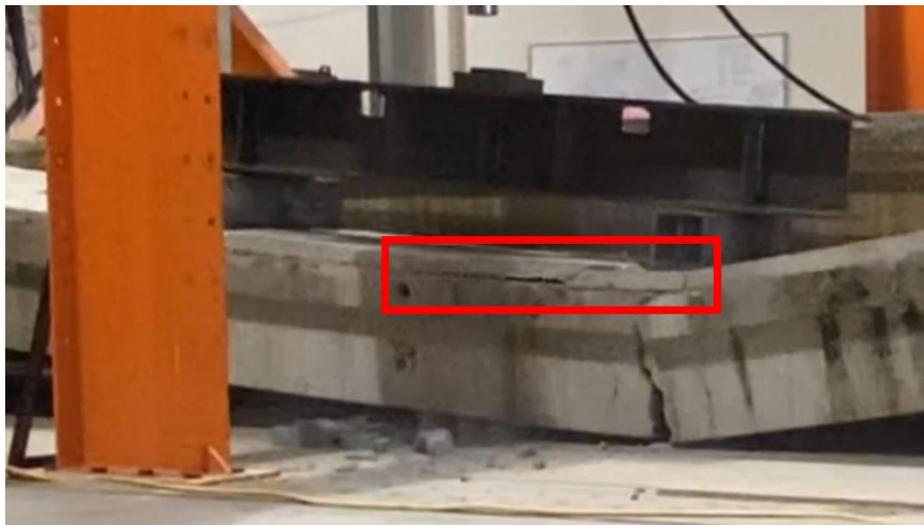
Figure 4.40: Delamination of Overlay as Seen After Flexural Failure
