Choices Behind the Color: An Analysis of Paint Finish Variations in South Carolina Slave Dwellings

CHOICES BEHIND THE COLOR: AN ANALYSIS OF PAINT FINISH VARIATIONS
IN SOUTH CAROLINA SLAVE DWELLINGS

In Partial Fulfillment
of the Requirements for the Degree
Master of Science
Historic Preservation

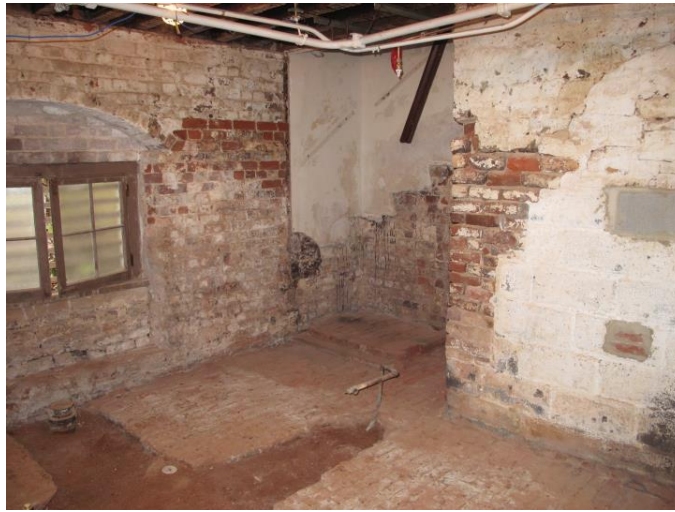
Figure 2.2 Image by Dr. Susan Buck. Southwest corner of South Pavilion cellar.

limewashes and then eventually with unpigmented limewashes. Limewashes in moist cellar spaces are particularly problematic for paint archaeology as they are vulnerable to flaking and chalking, but an attempt was made to remove samples from areas that might be datable.³⁵

The yellow-pigmented limewash is not reflected in the rooms above the cellar, so it is unclear as to where the pigment came from. The introduction of a pigment may have been included in the space with the addition of the stove since it was added at a later date.

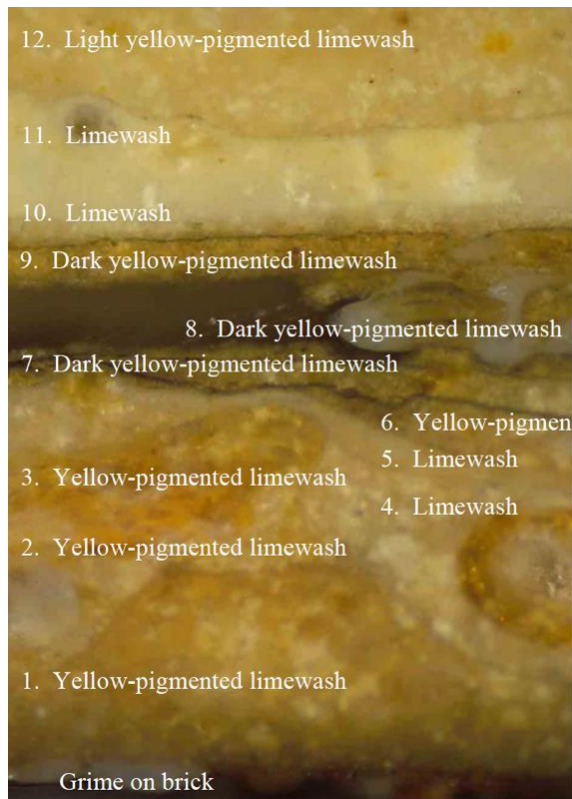
Figure 2.3 Microscopy sample by Susan Buck. Visible light, 100X, earliest layers of southwest corner, west wall.

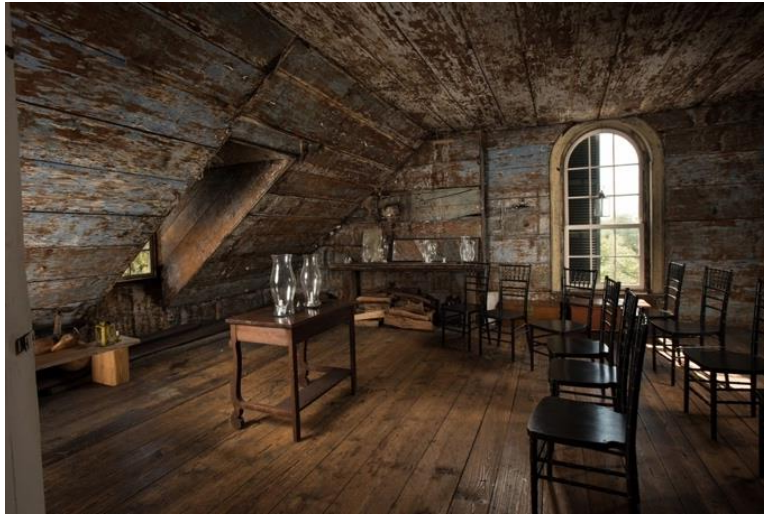
Figure 2.4 The Davenport House attic, image courtesy of the Historic Savannah Foundation.

Through investigation of these layers, architectural conservator George Fore discovered “that the blue is the last layer of paint on the wood surface not the first and that it probably dates from the 1890s or later. So it is not a vestige of enslaved autonomy (painting their living spaces within a master’s household).”⁴¹ Louise Miller Cohen, founder of Hilton Head Island’s Gullah Museum, claims that haint blue was never mentioned in her family history. Cohen states that ““people are saying that we paint our houses blue to ward off the evil spirits. If that was true, all the houses on the island would be painted blue.”⁴² This statement disputes the theory that haint blue may have been consciously used for spiritual purposes. The Davenport House openly rejects the theory that haint blue is a symbol of the Gullah Geechee culture, used to keep evil spirits away. However, there is no publication stating what the haint blue in the Davenport House signifies or where exactly it came from.

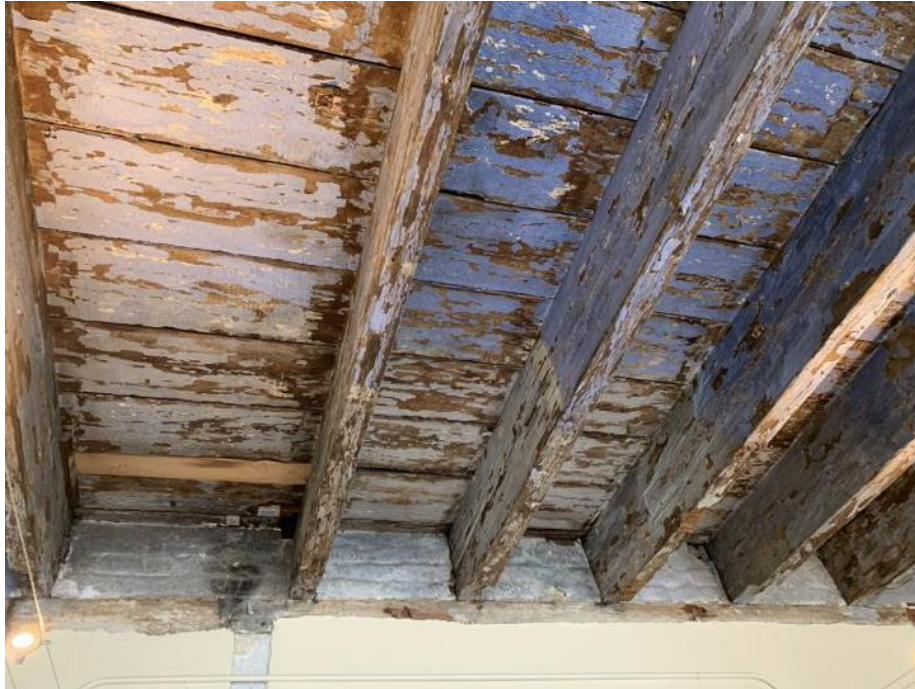
Figure 2.5 Image by Dr. Susan Buck. Ceiling and west wall of first floor Carriage House with partition ghosts.

Blue-pigmented limewashes were found in the bathing room as well as the ceiling and floor joists of the Carriage House.

expensive than indigo, so this pigment required deliberate purchase or use of leftover pigments from elsewhere in the house.⁴⁹

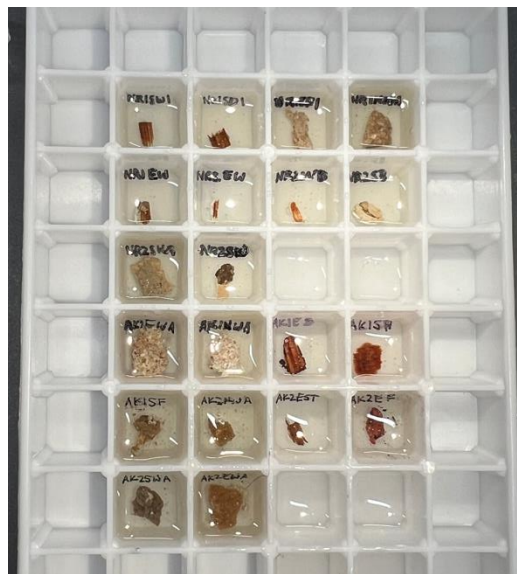
Figure 3.2 Samples from Nathaniel Russell and Aiken-Rhett house set in resin by author.

numbers. A grid legend on a piece of paper was used to indicate which grid space was associated with which paint sample using the same sample number identifying key. Samples were taken one at a time and placed on a watch glass. One drop of Cyanoacrylate, commonly known as crazy glue, was used at the bottom center of the resin cubes. Samples were then placed onto the glue to avoid movement while filling the rest of the cube with resin. The samples were placed in a vertical orientation with the modern paint facing down. Once all samples were placed, a ratio of fifteen parts of Bio-Plastic® to five drops of the Catalyst component was combined to make the resin mixture.⁵³ The resin mixture was then poured on top of the samples and the tray of samples was set inside the vent hood to solidify and cure for 24 hours.

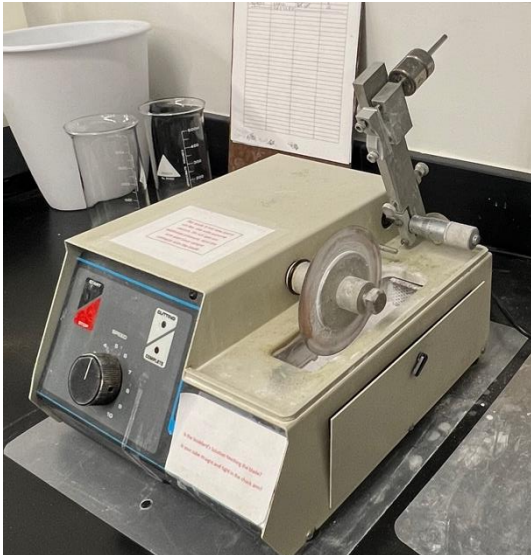
Figure 3.3 Buehler IsoMet® Low Speed Precision Cutter, image by author.

with the cut edge facing up. A level was used to ensure that the cut edge was even and parallel to the slide below.

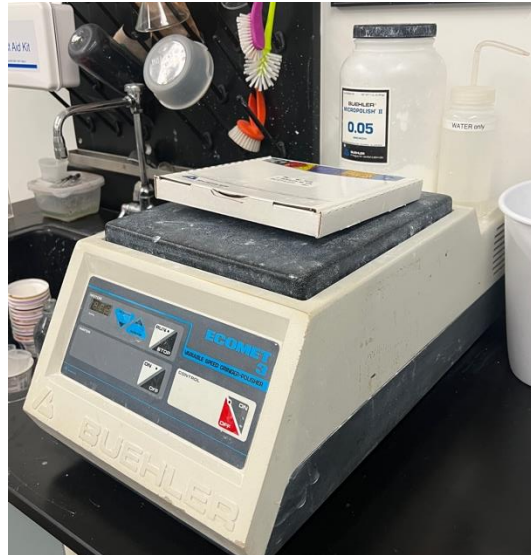
Figure 3.4 Buehler EcoMet® 30 Manual Grinder-Polisher, image by author.

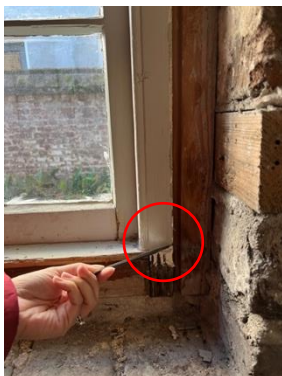
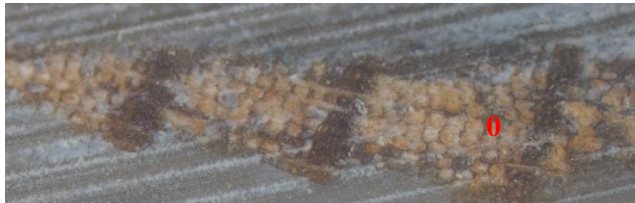
4.1 NR1SW1- 1st fl. South façade window trim
Visible Light 10X

0. Nothing visible on wood

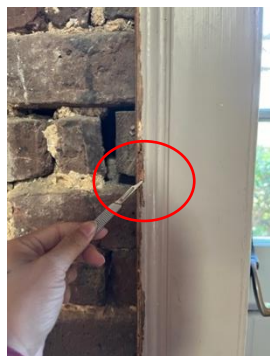
4.2 NR1SD1- 1st fl. South façade door trim
Visible Light 10X

| 5. 2.5BG 4/2 |

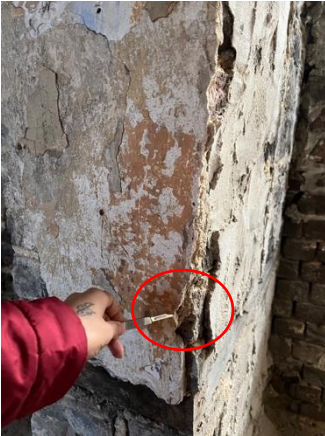
4.3 NR1EF1- 1st fl. East façade fireplace
Visible Light 10X

| 4. 2.5Y 7/4 |

- 4. Yellow cream
- 3. Debris, possibly soot
- 2. Yellow cream
- 1. Cream with jumbled repair material
- 0. Stucco substrate

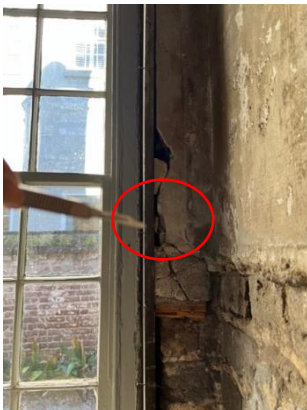
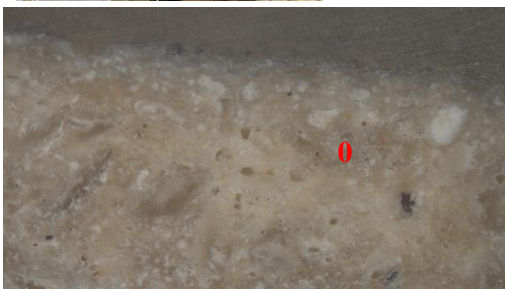
4.4 NR1NWA1- 1st fl. North wall
Visible Light 10X

- 0. Stucco substrate with plaster, no layers visible

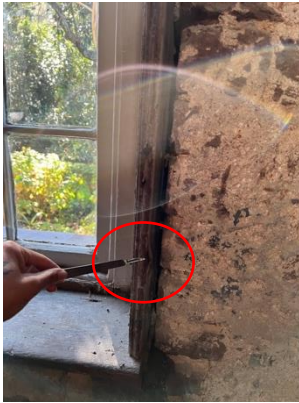
4.5 NR1EW1- 1st fl. East façade window trim
Visible Light 10X

| <ul style="list-style-type: none"> 4. 10 YR 9/1 3. Repair material 2. N 9.5 1. 2.5BG 8/2 |

- 4. Cream
- 3. Clear fill material
- 2. Modern off-white
- 1. Pale mint with dirt
- 0. Wood substrate, rough surface potentially caused by paint preparation

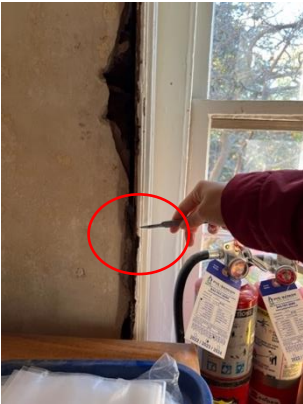
4.6 NR2EW1- 2nd fl. East façade window trim
Visible Light 10X

| <ul style="list-style-type: none"> 3. N 9.5 2. Repair material 1. N 9.5 |

- 3. Modern off-white
- 2. Clear fill material
- 1. Primer
- 0. Wood substrate, rough surface potentially caused by paint preparation

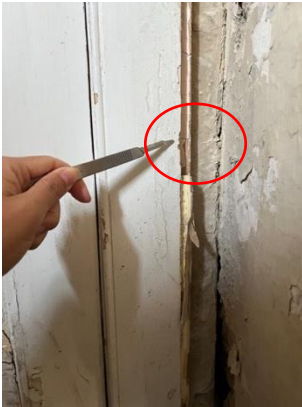
4.7 NR2WD1- 2nd fl. West façade door trim
Visible Light 10X

- 7. 10YR 7/6
- 6. 10YR 9/4
- 5. 2.5BG 8/2
- 4. 10YR 9/1
- 3. 5YR 9/4
- 2. 5YR 8/4
- 1. 10YR 9/1

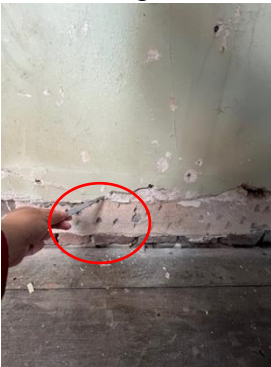
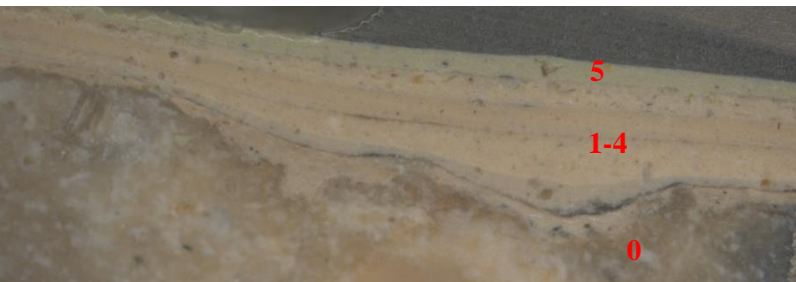
4.9 NR2SWA1- 2nd fl. South façade wall
Visible Light 10X

| 5. 5GY 8.5/2 |

- 5. Pale mint
- 1-4. Layers of yellow cream with debris
- 0. Stucco

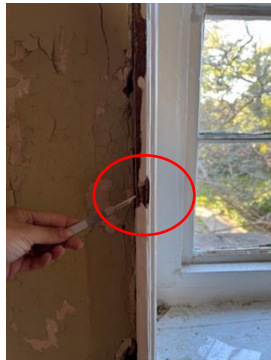
4.10 NR2SW1- 2nd fl. South window
Visible Light 10X

| 5. 10YR 9/2 |

- 20. Modern white
- 19. Cream or topcoat
- 18. Repair fill material
- 17. Primer
- 11-16. Layer of cream with white in-between
- 10. Light blue
- 9. Cream
- 8. Light blue
- 7. Pale mint
- 4-6. Layers of jumbled yellow cream
- 3. Dark brown
- 2. Light brown
- 1. Tan
- 0. Wood substrate

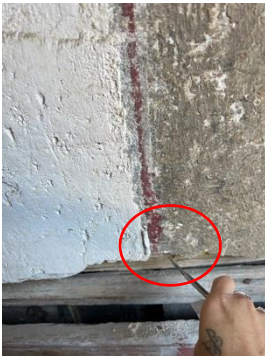
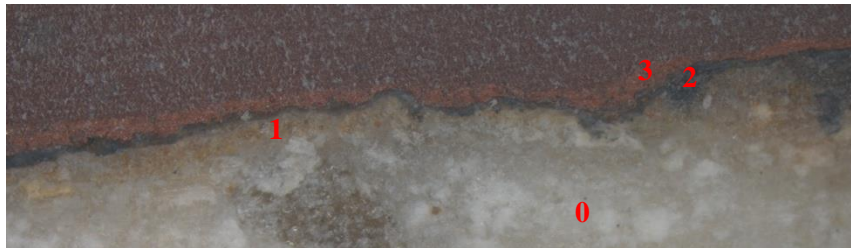
4.19 AK1EWA1- 1st fl. East façade wall
Visible Light 10X

| 3. 2.5YR 3/4 |

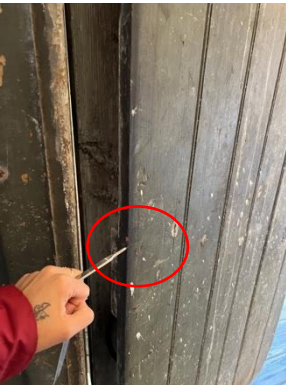
4.21 AK1ED1- 1st fl. East façade door
Visible Light 10X

- 2. 2.5G 7/2
- 1. 10Y 2.5/1

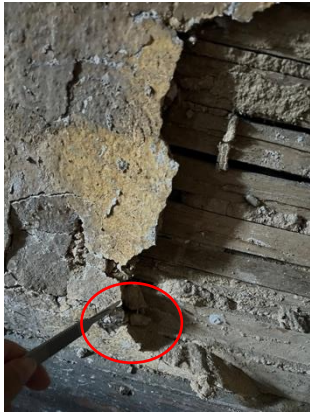
4.23 AK1SF1- 1st fl. South façade fireplace
Visible Light 10X

- 8. 10YR 8/6
- 5-7. 10YR 9/2
- 4. 10YR 6/2
- 3. 10R 7/6
- 2. 10YR 9/2
- 1. 7.5YR 8/4

- 11. Tan
- 10. Pink limewash
- 9. Tan
- 8. Yellow limewash
- 5-7. layers of cream
- 4. Tan
- 3. Pink limewash
- 2. Cream, uneven, pink seeped from above layer
- 1. Orange limewash
- 0. Stucco substrate

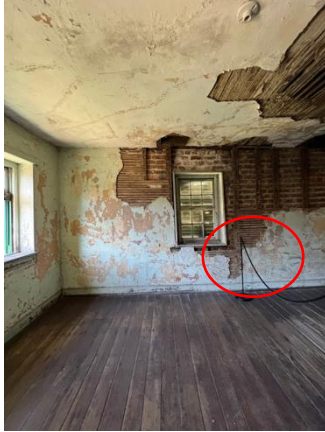
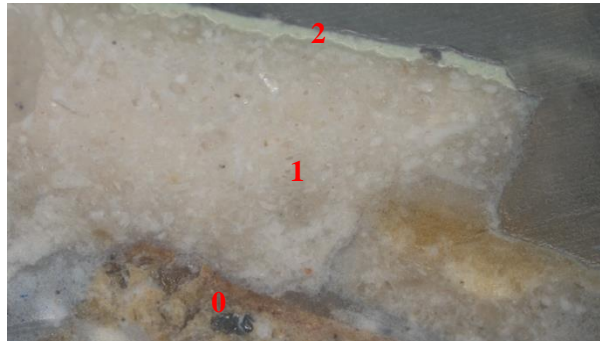
4.24 AK2NWA1- 2nd fl. North façade wall
Visible Light 10X

2. 7.5GY 9/2
1. Stucco

2. Pale mint
limewash
1. Stucco with
separation
0. Wood
substrate

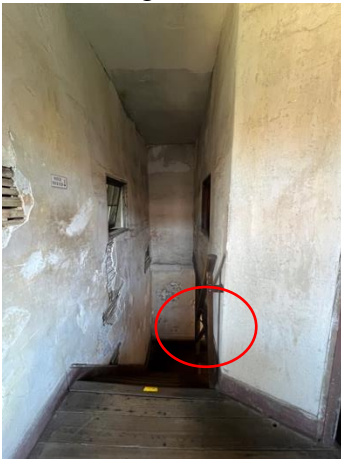
4.25 AK2EST1- 2nd fl. East façade stair hall wall
Visible Light 10X

2. 10YR 9/2
1. 10YR 9/4

2. Cream
1. Remnants or fragments of
ochre layer
0. Wood substrate, potential
paint prep

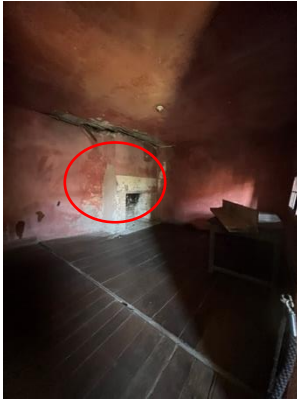
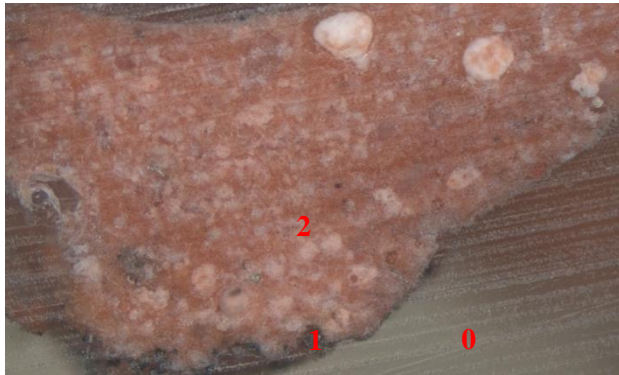
4.26 AK2EF1- 2nd fl. East façade fireplace
Visible Light 10X

2. 7.5R 5/6 1. Dirt

- 2. Thick red limewash
- 1. Potentially black pigment or soot
- 0. Separated from wood substrate

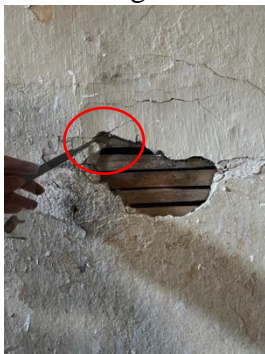
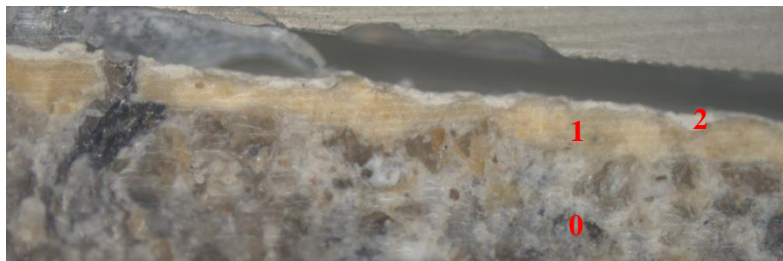
4.27 AK2SWA1- 2nd fl. South façade wall
Visible Light 10X

2. 10YR 9/1 1. 10YR 9/4

- 2. Thin white
- 1. Yellow cream
- 0. Plaster, top layer has been abraded

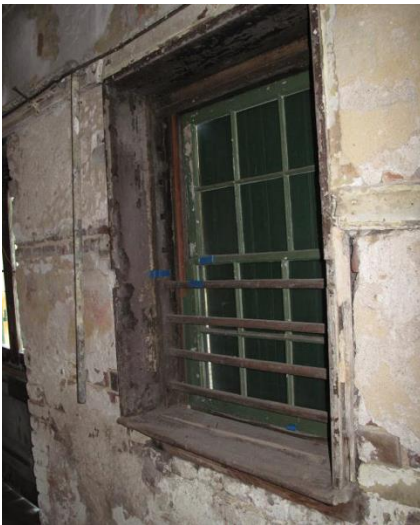
4.29 K101-II-11. West wall, center window, lower bar across

- 19. Modern red-brown
- 18. Off-white
- 17. Red-brown
- 16. Blackish-green
- 15. Dark resinous green
- 14. Medium green
- 13. Pale gray-green
- 12. Gray
- 11. Brown with resinous coating
- 10. Brown with resinous coating
- 9. Brown resinous coating
- 8. Gray paint
- 7. Brown paint
- 6. Black paint
- 5. Tannish-gray paint
- 4. Tan paint with resinous coating
- 3. Dark green resinous coating
- 2. Dark gray oil paint
- 1. Tan or cream oil in paint
- 0. Shellac in wood

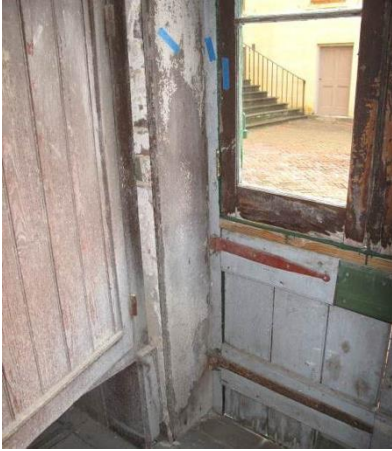
4.30 K101-II-1. West wall, south door, original door reveal, left side about 4' to confirm Period I woodwork chronology
Visible Light 200X

- 7. Modern red-brown
- 6. Off-white
- 5. Red-brown
- 4. Brown with resinous coating
- 3. Off-white
- 2. Dark gray oil paint
- 1. Tan or cream oil in paint
- 0. Wood substrate

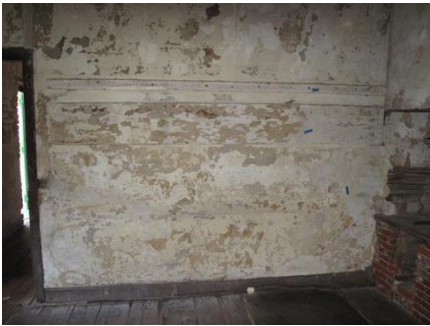
4.31 K101-II-2. North wall, south door, later door in Period II partition wall, left side
Visible Light 200X

- 13. Light gray
- 12. Modern red-brown
- 11. Off-white
- 10. Red-brown
- 9. Blackish-green
- 8. Dark resinous green
- 7. Medium green
- 6. Pale gray-green
- 5. Brown with resinous coating
- 4. Off-white
- 3. Gray paint
- 2. Tan paint
- 1. Tannish-gray paint
- 0. Pigmented varnish

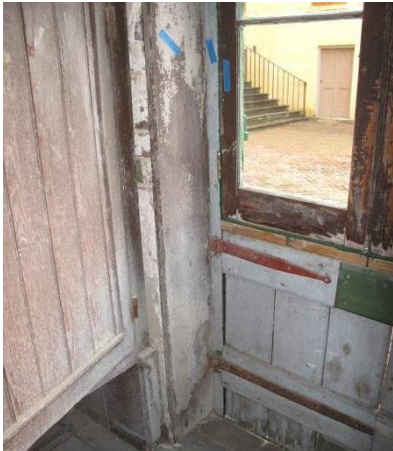
4.32 K101-II-3. West wall, south door, later glazed door, left stile about 4' up
Visible Light 200X

- 7. Modern red-brown
- 6. Off-white
- 5. Red-brown
- 4. Dark resinous green
- 3. Medium green
- 2. Pale gray-green
- 1. Brown with resinous coating
- 0. Primer with white zinc

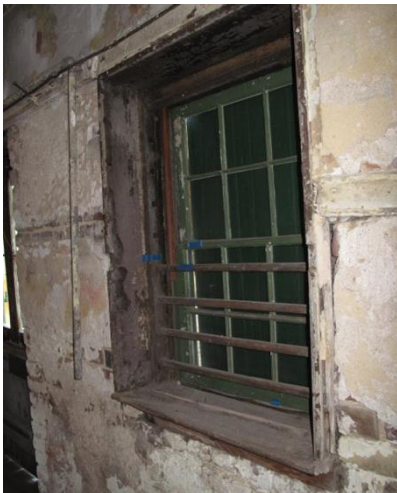
4.33 K101-II-12. West wall, later window sash
Visible Light 200X

- 7. Green
- 6. Light gray
- 5. Gray
- 4. Brown with resinous coating
- 3. Brown resinous coating
- 2. Cream
- 1. Cream

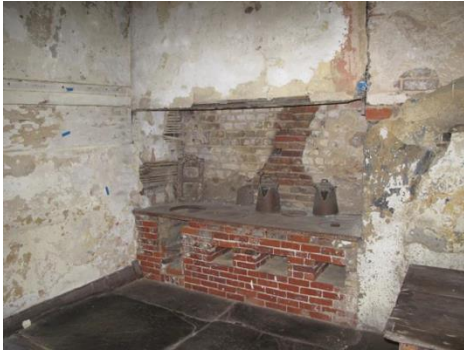
4.34 K101-II-5. East wall, plaster above later installations of stew stove, 1858 plaster on circular sawn lath, for comparative dating
Visible Light 100X

- 10. Pale yellow wash
- 9. Dark yellow paint
- 8. Unpigmented limewash
- 7. Deep orange paint
- 6. Deep orange wash
- 5. Unpigmented limewash
- 4. Tannish wash
- 3. Unpigmented limewash
- 2. 1858 Sandy white coat
- 1. 1858 Brown coat

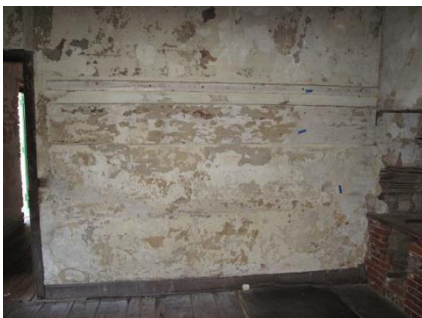
4.35 K101-II-7. North wall, wide board about 3' from northeast corner
Visible Light 200X

- 8. Unpigmented limewash
- 7. Yellow wash
- 6. Unpigmented limewash
- 5. Bright yellow wash
- 4. Pale orange at wainscot level
- 3. Pale orange
- 2. Dark gray at wainscot level
- 1. Unpigmented/gray wash
- 0. White coat plaster Period II

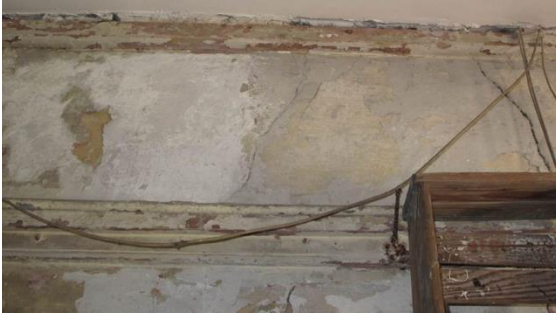
4.36 K101-II-16. Board just above pegrail used to support gas pipe and later support water pipe, on south wall just above door
Visible Light 40X

- 8-9. Opaque off-white paints
- 7. Pale yellow wash
- 6. Unpigmented limewash
- 5. Dark yellow paint
- 4. Unpigmented limewash
- 3. Deep orange paint
- 2. Unpigmented limewash
- 1. Unpigmented limewash

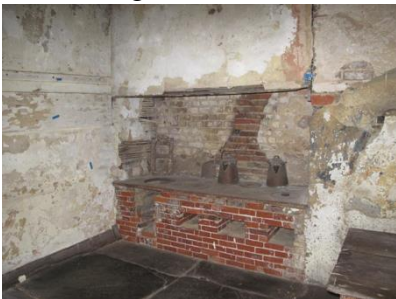
4.37 K102-II-8. North wall, Period I baseboard, just right of door opening, to identify original paint and for comparison with Period II baseboard
Visible Light 200X

- 6. Pigmented varnish
- 5. Green
- 4. Medium brown
- 3. Light brown
- 2. Brown with varnish
- 1. Light brown on cream-colored primer

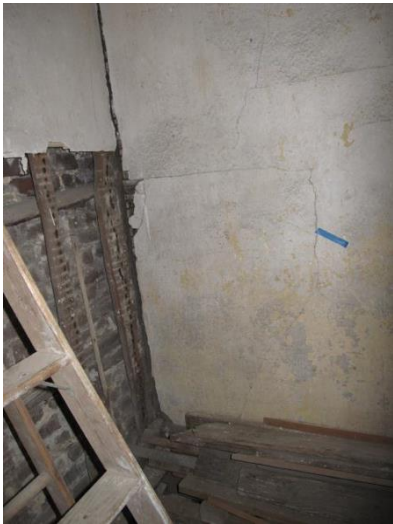
4.40 K104-II-3. South wall, southeast corner, at crack about 4' up
Visible Light 100X

- 10. Dark yellow pigmented limewash
- 9. Dark yellow pigmented limewash
- 8. Orange pigmented limewash
- 7. Unpigmented limewash
- 6. Yellow pigmented limewash
- 5. Yellow pigmented limewash
- 1-4. Unpigmented limewash
- 0. Period II plaster

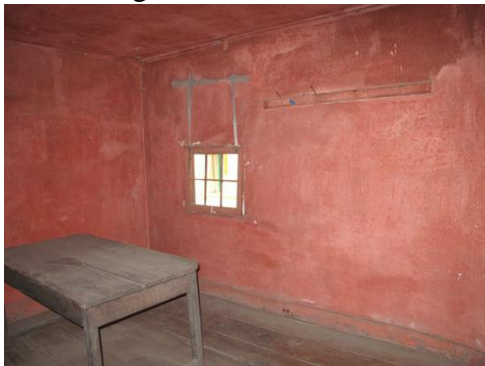
4.41 K203-II-4. West wall pegrail, lower edge for comparison for paint chronology
Visible Light 200X

- 5. Pink paint remnants
- 4. Black
- 3. Brown (generation 11 in K101)
- 2. Shellac
- 1. Red-brown paint on wood

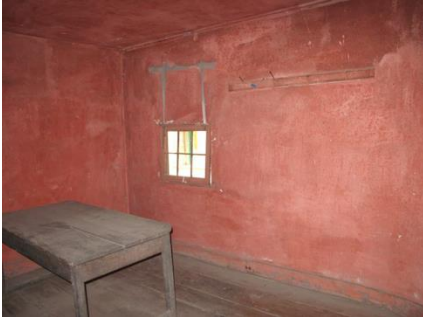
4.42 K203-II-3. West wall, on grayish ghost behind position for former curtain support for comparison
Visible Light 200X

- 4. Unpigmented limewash
- 3. Pinkish-orange limewash
- 2. Yellow pigmented limewash
- 1. Unpigmented limewash
- 0. Brown coat of plaster

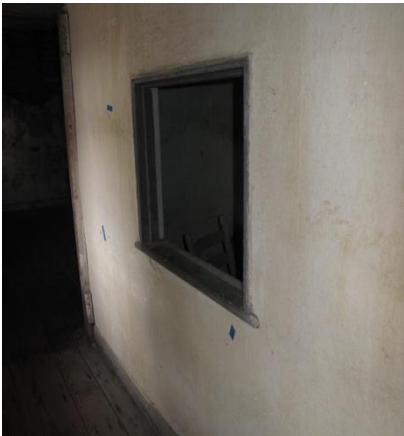
4.43 K204B-II-4. East wall rob window, upper left corner of window frame (early blue paint is present)
Visible Light 200X

- 4. Medium blue paint (now degraded to dark blue-black)
- 3. Gray with zinc white (post-1845)
- 2. Cream-colored paint
- 1. Cream-colored paint

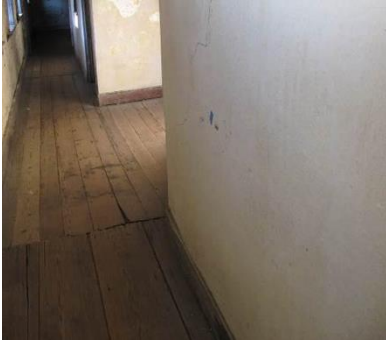
4.44 K204A-II-1. East wall, near join of Period II building, faux black wainscot can be seen below peeling paint
Visible Light 100X

- 12. Yellow pigmented limewash
- 11. Yellow pigmented limewash
- 10. Unpigmented limewash
- 9. Yellow pigmented limewash
- 8. Orange pigmented limewash
- 7. Unpigmented limewash
- 6-7. Unpigmented limewash
- 4-5. Dark gray limewash
- 3. Unpigmented limewash
- 2. Dark gray limewash
- 1. Yellow pigmented limewash
- 0. Plaster

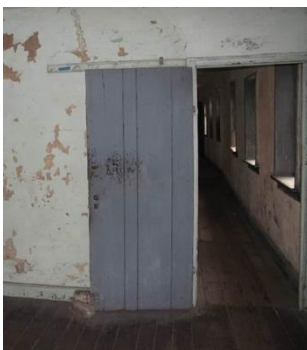
4.45 K206-II-1. South wall pegrail
Visible Light 200X

- 4. Modern white
- 3. Light gray paint with varnish (contains zinc white)
- 2. Brown paint
- 1. Cream color with varnish (Period II)

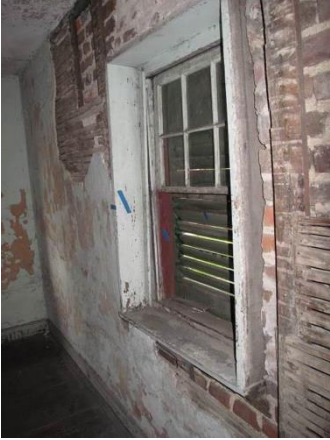
4.46 K206-II-2. North wall, inserted window, likely in Period III, reveal on left side, to establish the later paint sequence

5. Modern white
4. Dark gray
3. Light gray paint with varnish (contains zinc white)
2. Gray paint with zinc white
1. Cream color with varnish (Period II)

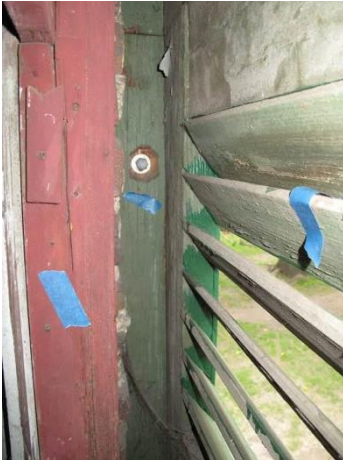
4.47 K206-II-3. North wall, inserted window, likely in Period III, red paint on exterior of window frame

2. Modern red paint
1. Red-orange paint on dirty wood substrate

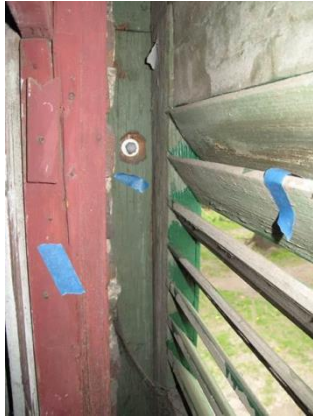
4.48 K206-II-4. North wall, inserted window, likely in Period III, green on exterior of underside of Gothic arch, left side
Visible Light 200X

2. Modern green on gray primer
1. Red-orange paint on dirty wood substrate

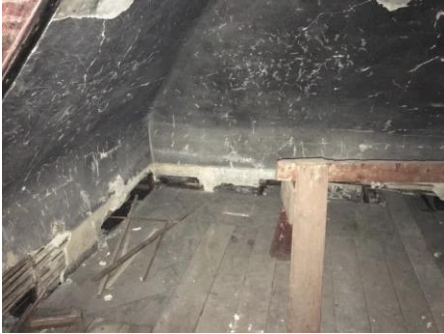
4.49 3-1. 3rd fl. south wall, west side of window, accumulation of reds and yellow limewashes below blackened surface.

- 13. Unpigmented limewash
- 12. Gray pigmented limewash
- 11. Yellow pigmented limewash
- 9-10. Unpigmented limewash
- 8. Yellow pigmented limewash
- 7. Unpigmented limewash
- 6. Orange pigmented limewash
- 2-5. Unpigmented limewash layers
- 1. Unpigmented limewash
- 0. Plaster substrate

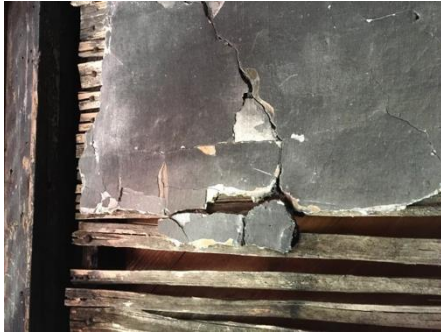
4.50 3-2. 3rd fl. south wall, southwest corner, about 1-foot above baseboard level

- 18-19. Layers of unpigmented limewashes
- 17. Orange pigmented limewash
- 13-16. Layers of unpigmented limewashes
- 12. Yellow pigmented limewash
- 5-11. Layers of orange pigmented limewashes
- 3-4. Layers of unpigmented limewashes
- 1-2. Layers of yellow pigmented limewashes
- 0. Plaster substrate

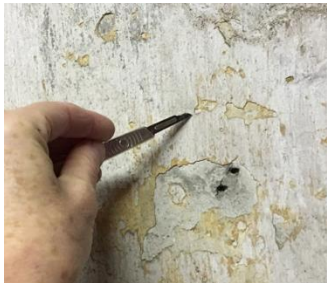
4.51 2-3. 2nd fl. East room, north wall above wainscot

- 8. Unpigmented limewash
- 7. Orange pigmented limewash
- 3-6. Unpigmented limewash
- 2. Unpigmented limewash
- 1. Pinkish pigmented limewash
- 0. Plaster substrate with grimy surface

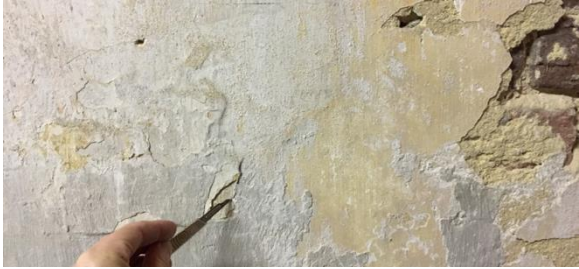
4.52 2-4. 2nd fl. East room, north wall below wainscot
Visible Light 200X

9-14. Unpigmented limewashes
8. Orange pigmented limewash
1-7. Layers of unpigmented limewashes

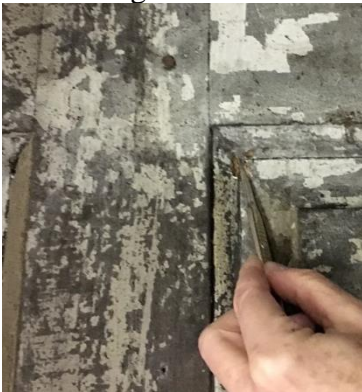
4.53 2-5. 2nd fl. Door to east room, passage side, upper right corner of middle right panel
Visible Light 200X

4. Chalky Gray
3. Tannish brown
2. Brown with charred surface
1. Gray
0. Wood substrate

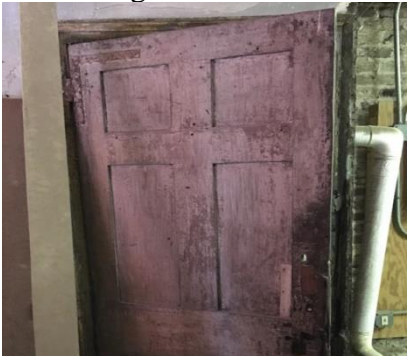
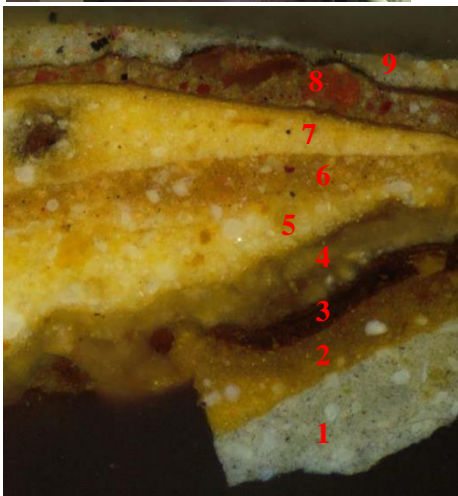
4.54 2-6. 2nd fl. Door to east room, room side, upper right corner of middle right panel
Visible Light 200X

- 9. Gray
- 8. Dark brown
- 7. Dark yellow
- 6. Orange-brown
- 5. Dark yellow
- 4. Limewash
- 3. Dark brown
- 2. Brown
- 1. Gray

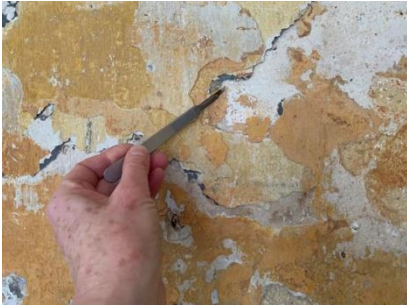
4.62 L-1. North wall, yellow limewash under blue, east side
Visible Light 100X

- 11. Yellow pigmented limewash
- 10. Unpigmented limewash
- 9. Yellow pigmented
- 7-8. Unpigmented limewash
- 6. Soot embedded in limewash
- 1-5. Layers of unpigmented limewash

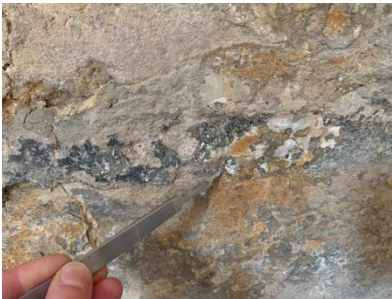
4.63 L-2. North wall, plaster and wash on wall of possible missing shelf, west side
Visible Light 100X

- 9. Unpigmented limewash
- 8. Soot in embedded limewash
- 5-7. Yellow pigmented limewash
- 2-4. Layers of unpigmented limewash
- 1. Yellow pigmented limewash

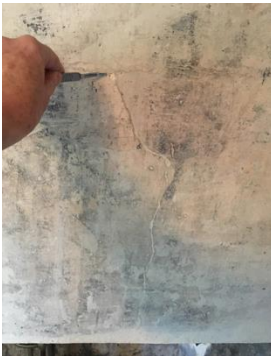
4.64 1. West chamber, north wall, pigmented limewashes on fireplace Visible Light 100X

- 1. Unpigmented limewash
- 0. Plaster substrate

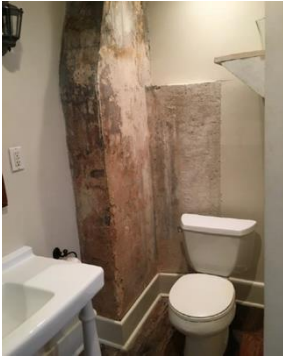
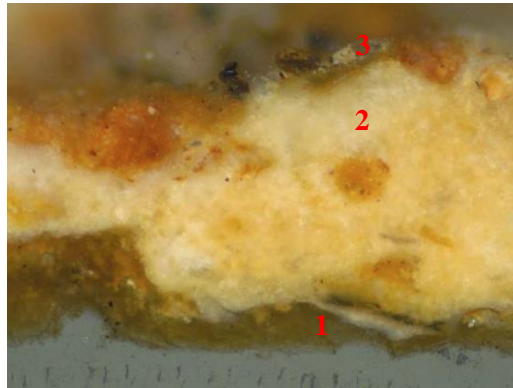
4.65 2. Middle chamber, north wall, pigmented limewashes on plastered fireplace
Visible Light 100X

- 3. Red-orange pigmented limewash
- 2. Dull yellow pigmented limewash
- 1. Reddish-brown pigmented limewash

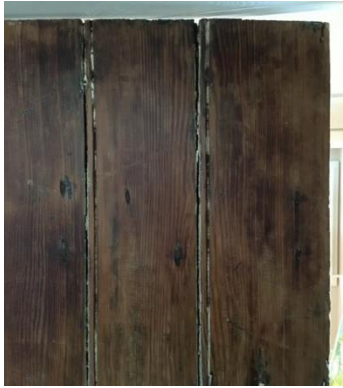
4.69 1. Front of 2nd fl. board door
Visible Light 100X

3-6. Layers of off-whites
2. Gray with zinc white
1. Green paint
0. Wood substrate

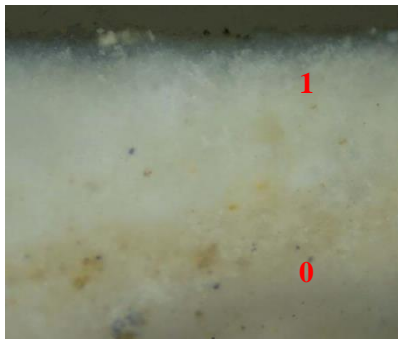
- 3. Yellow pigmented limewash (similar to sample 5)
- 2. Yellow pigmented limewash
- 1. Unpigmented limewash
- 0. Plaster substrate

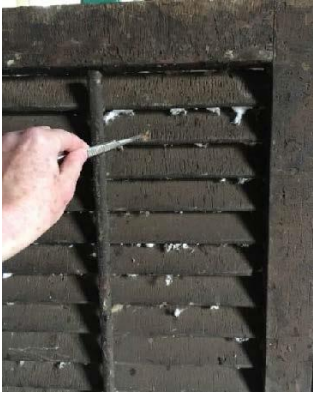
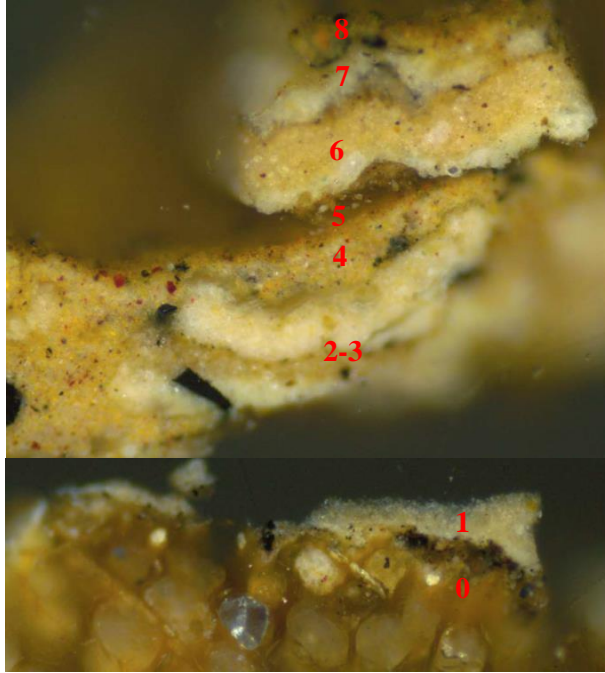
4.80 9. Detached louvered shutter, on interior side
Visible Light 100X

- 8. Orange-brown
- 7. Dull pinkish-yellow
- 6. Dull pinkish-orange
- 5. Orange-brown flowed into cracks
- 4. Dull yellow
- 2-3. Cream-colored paint
- 1. Cream-colored paint
- 0. Wood substrate with dirt

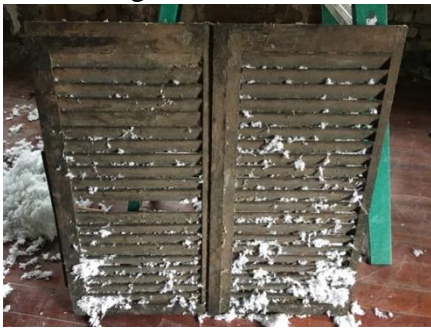
4.81 10. Detached louvered shutter, on exterior side, thick accumulations of weathered paints
Visible Light 100X

- 8. Orange-brown
- 7. Dull pinkish-yellow
- 6. Dull pinkish-orange
- 5. Dull yellow
- 4. Dark yellow
- 3. Dull yellow
- 2. Dull orange
- 1. Light tannish-orange

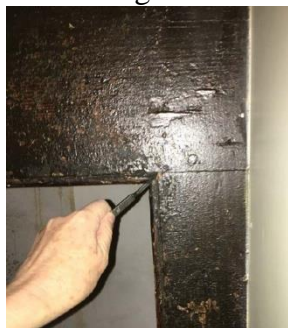
4.84 1. 2nd fl. east room, corner of mantel trapped in closet Visible Light 200X

- 8. Varnish
- 7. Light gray
- 6. Dark gray
- 5. Red-brown
- 3-4. Cream color
- 2. Red-brown
- 1. Cream color
- 0. Wood substrate

This site was constructed circa 1772 with alterations occurring in 1985, 1990, and 1991.⁶⁶ Sample One from the mantel exhibits a first layer of cream color that was painted on top of shellac. Red-brown and a matching cream color are following this generation. For Sample Two, the first layer appears to be a degraded plant resin varnish, followed by a black pigmented varnish, an unpigmented limewash, and opaque, finely ground 20th-century paints.

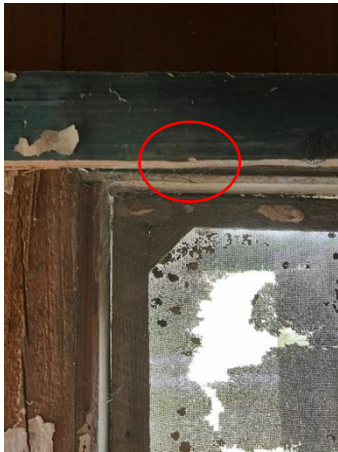
4.89 L1WN3- Window trim
Reflected Light 4X

1. 7.5G 3/4

- 1. Teal wash
- 0. Wood substrate

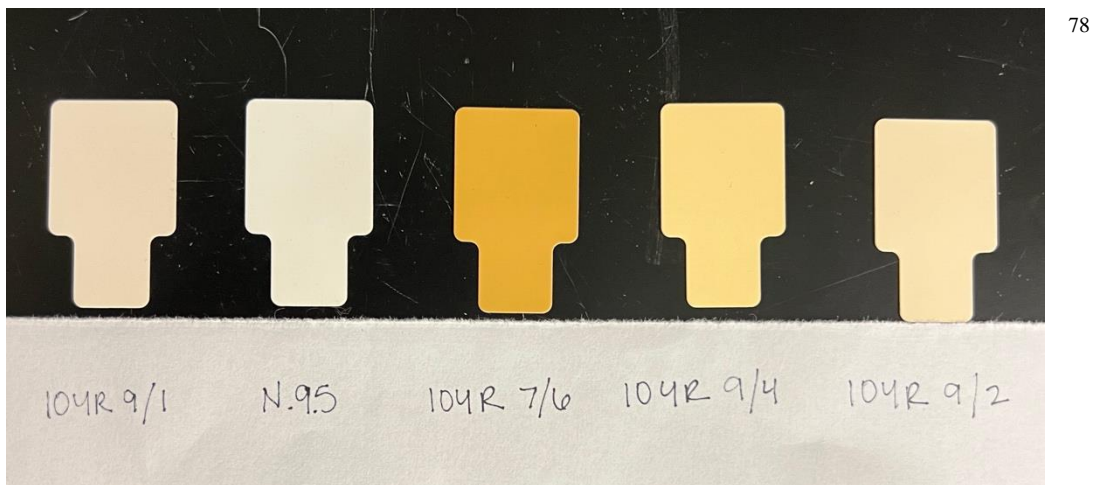
Figure 4.100 Munsell Notation chips. Photo by author.
